Schedule of Condition

Fox
29 High Street
Steventon
OX13 6RZ

28th November 2019

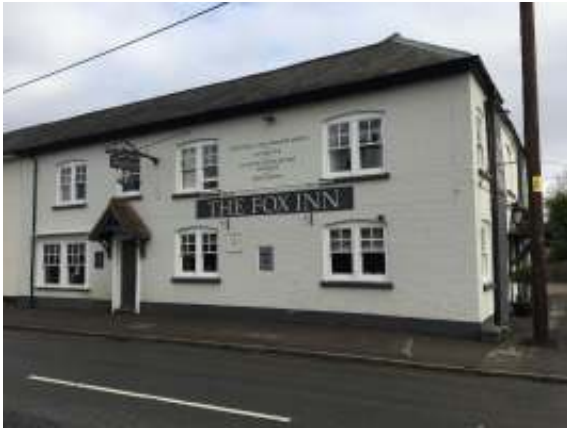
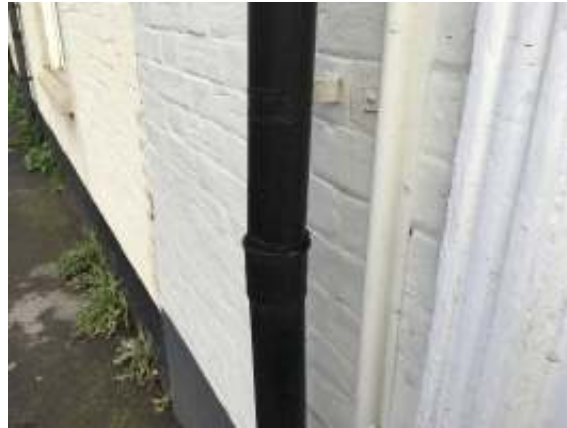
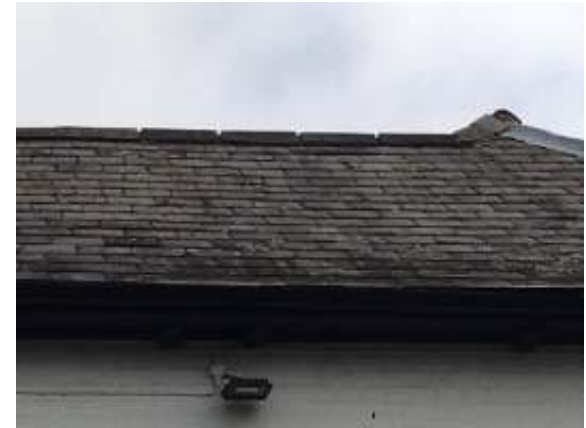
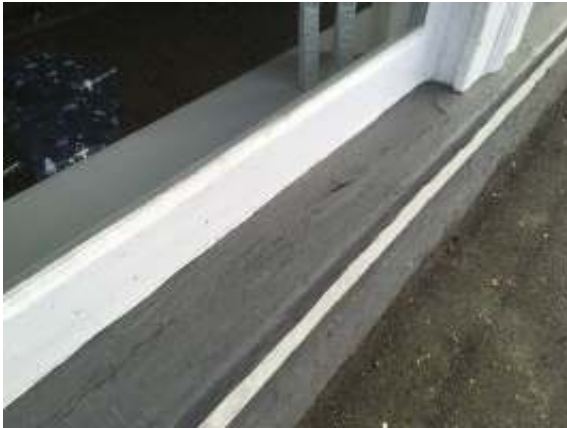
1.1	Front Elevation		Photographs [2-6]					
1.1.1	Rainwater Goods	Painted plastic gutters and downpipes with no surface water gullies.	Satisfactory Condition - broken bracket.

1.1.2	Roof	Pitched roof with natural slate covering, clay ridge tiles, lead covered hip detail and lead flashings.	Satisfactory Condition - gaps between ridge tiles. Minor lifting to slate.

1.1.3	Walls	Solid masonry wall with brick facing and painted decoration.	Good Condition -					
1.1.4	Joinery	Single glazed timber sash windows, pair of timber double doors with timber canopy and painted decoration.	Satisfactory Condition - some deterioration of paint finishes to sills.

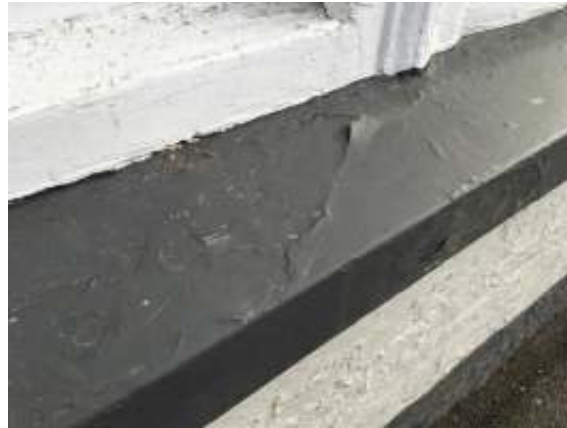
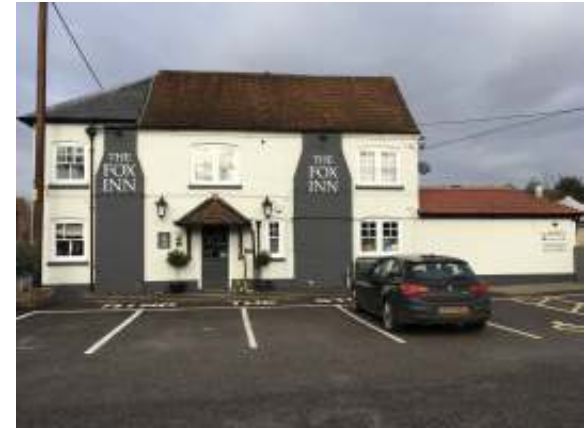
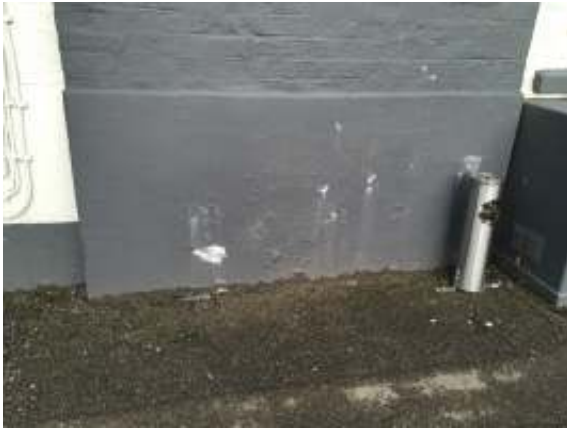
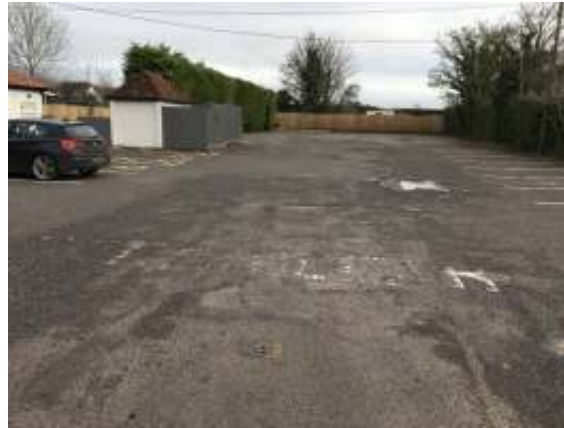
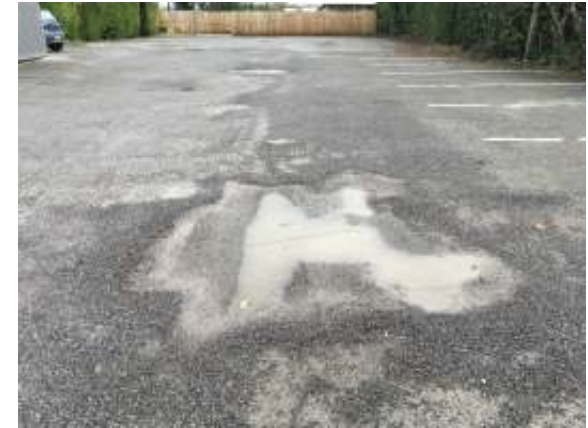
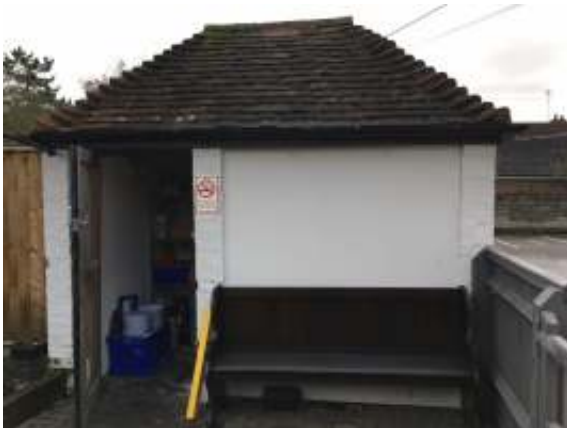
1.2.3	Walls	Solid masonry wall and cavity masonry wall with brick facing and painted decoration.	Good Condition - localised damage to finishes to chimney stack at low level.

1.2.6	Grounds	Area of tarmac hard standing with marked parking bays and footway. Enclosed with a combination of concrete blocks, feather board fencing and mature vegetation.	Satisfactory Condition - deterioration and pooling to tarmac surfacing.

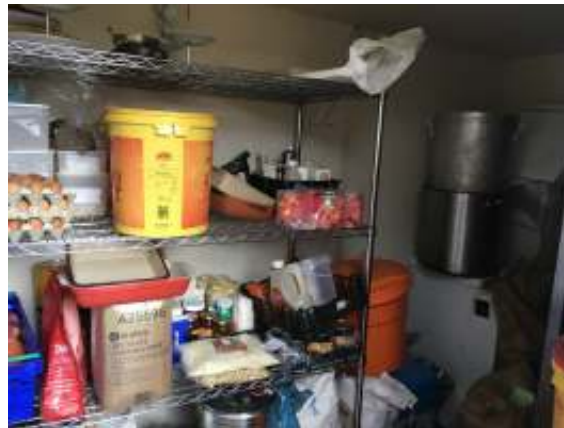
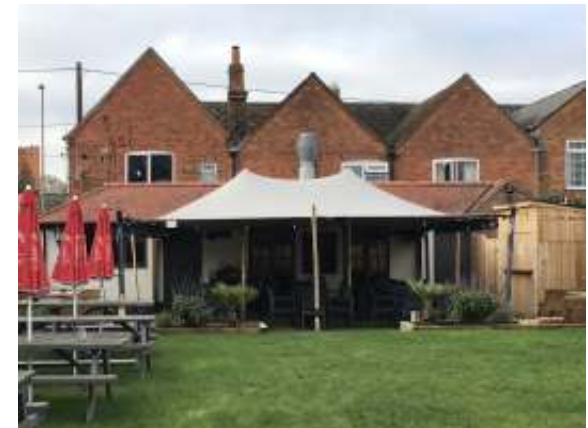
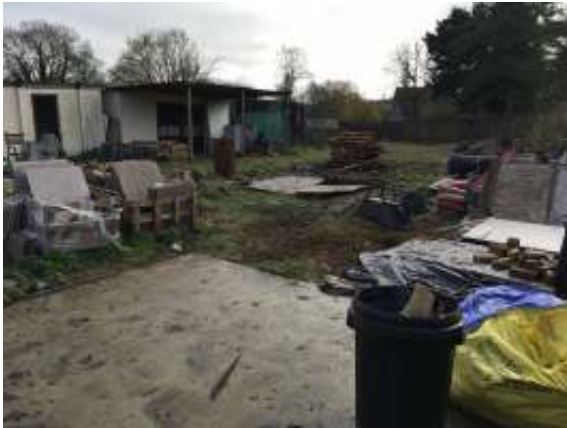
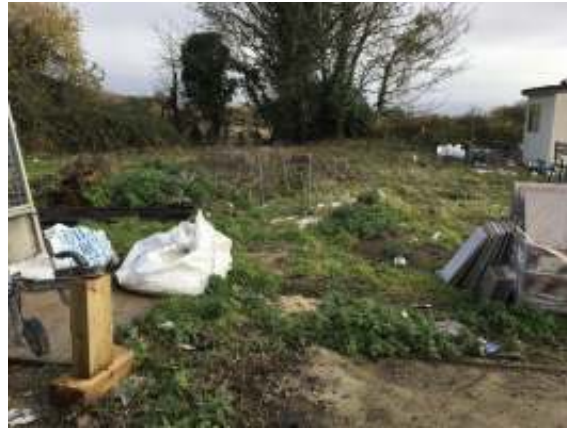
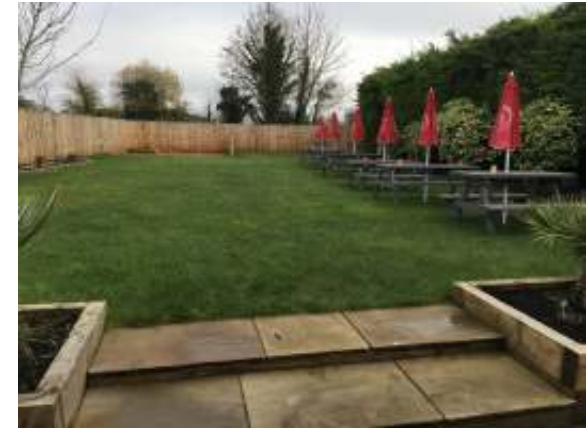
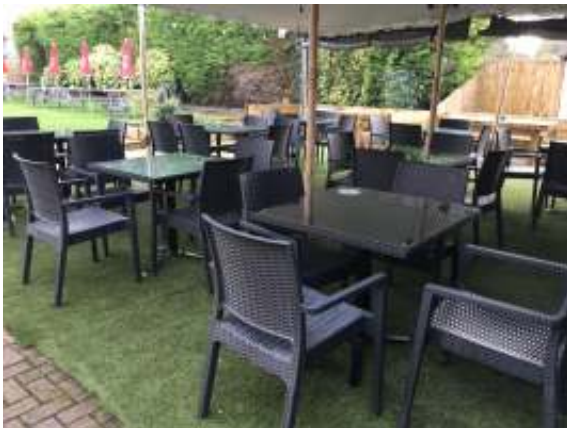
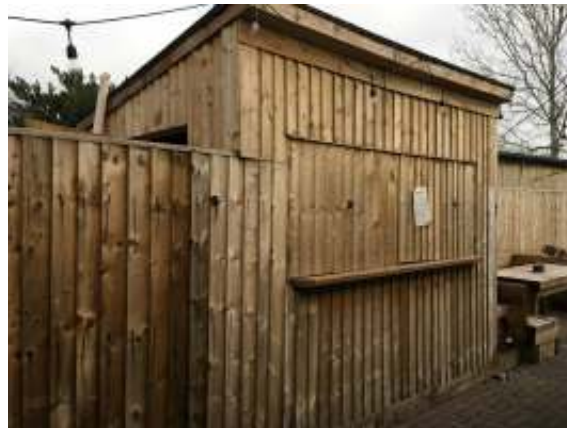
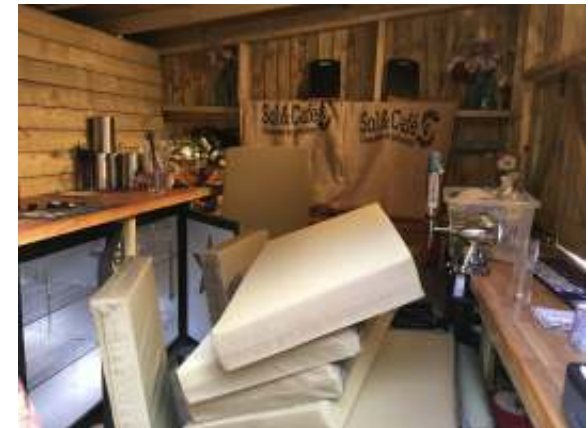
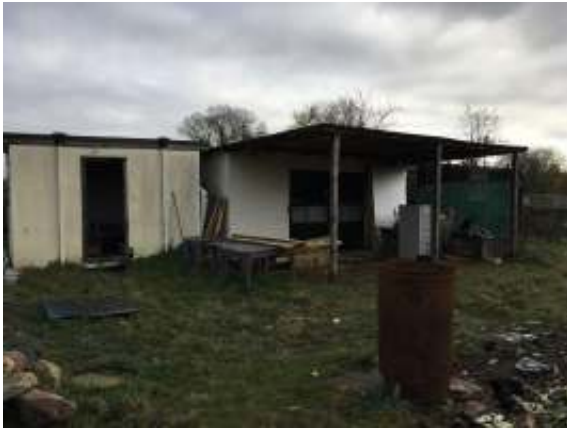
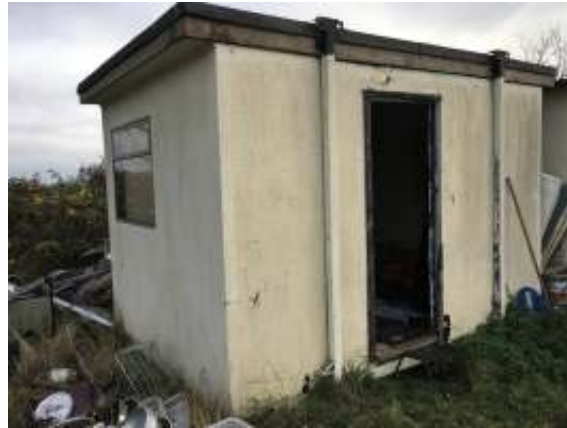
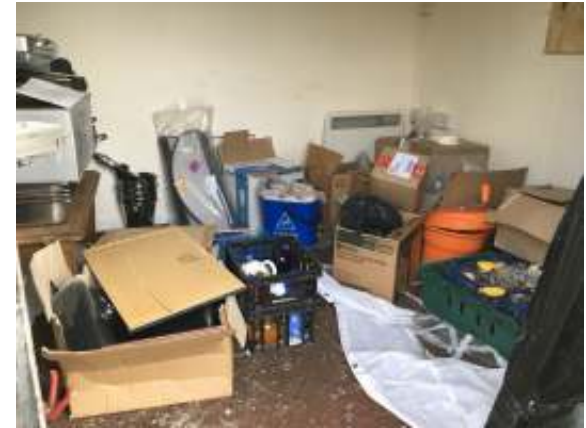
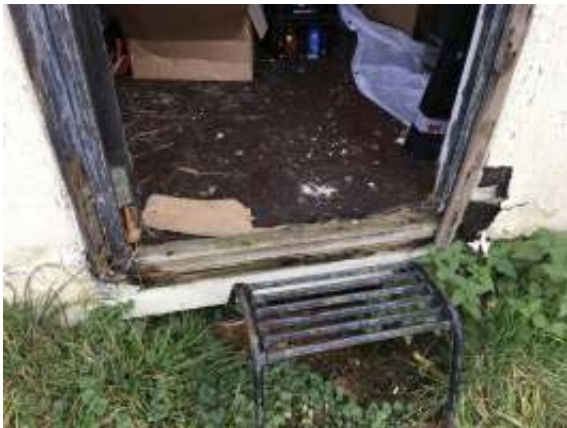
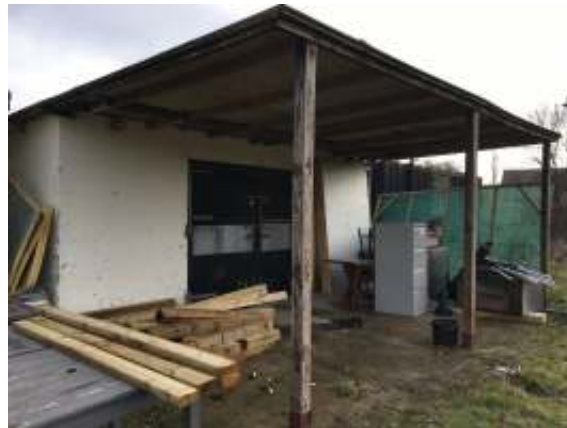
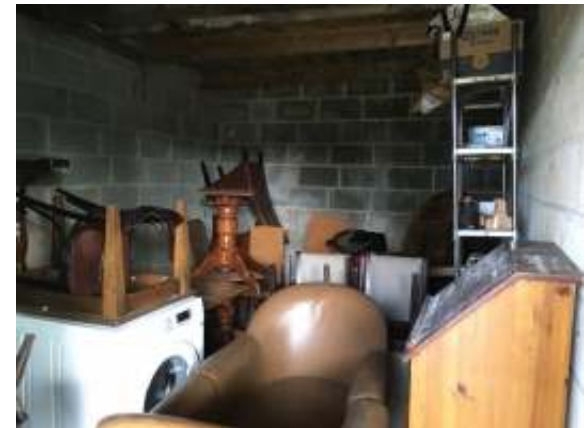
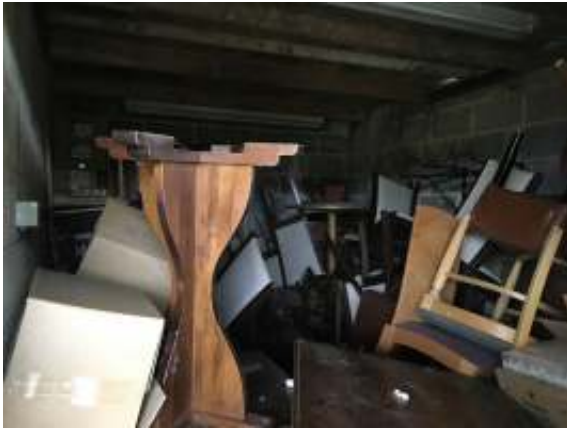
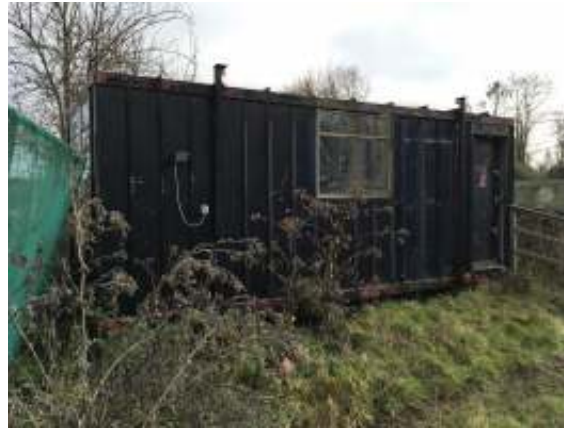
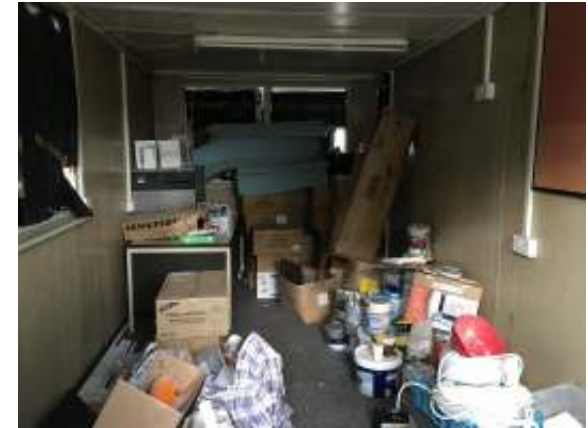
1.3.3	Roof	Multiple pitched roofs with clay tile and natural slate covering, clay ridge and hip tiles, with lead valleys and flashings. Section of flat roof with bitumen felt covering.	Satisfactory Condition - some tiles missing and build up of debris on the flat roof.

1.3.8	Grounds - Private	To the far rear is a private enclosed area used for storage with timber fencing and shrubbery to boundaries.	Poor Condition - area of wasteland with overgrown vegetation, rubbish and discarded items throughout.

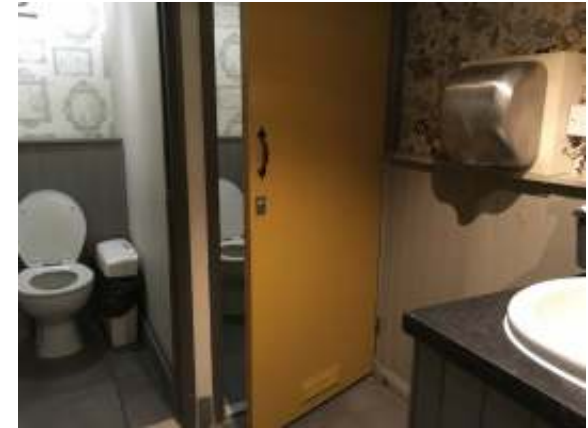
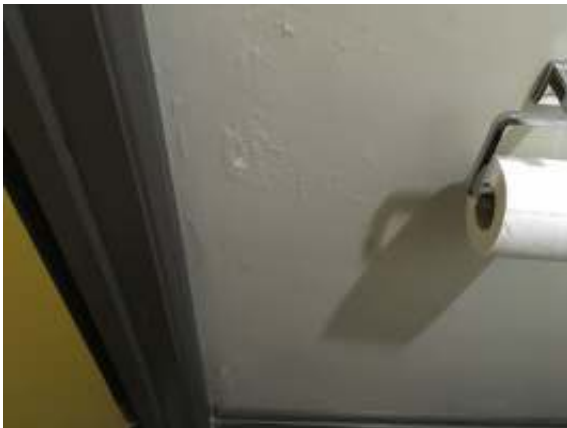
2.6	Ladies Toilets GF		Photographs [34-35]					
2.6.1	Ceilings	Plasterboard ceiling with lining paper and painted decoration.	Good Condition					
2.6.2	Walls	Mixed timber stud partitions and masonry walls with, plaster finishes, plasterboard lining, wall paper, ceramic tiles, timber panelling and paint decoration.	Good Condition - minor damp ingress within cubicle.

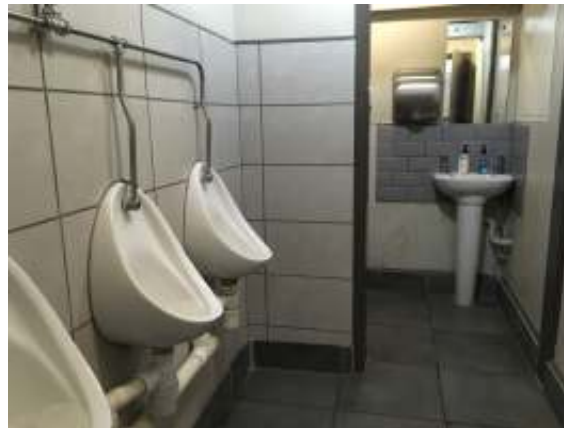
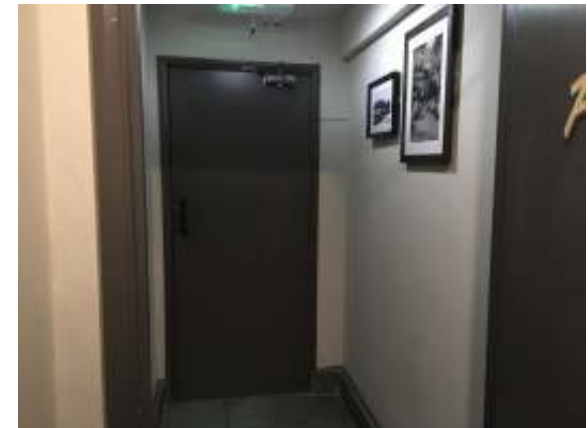
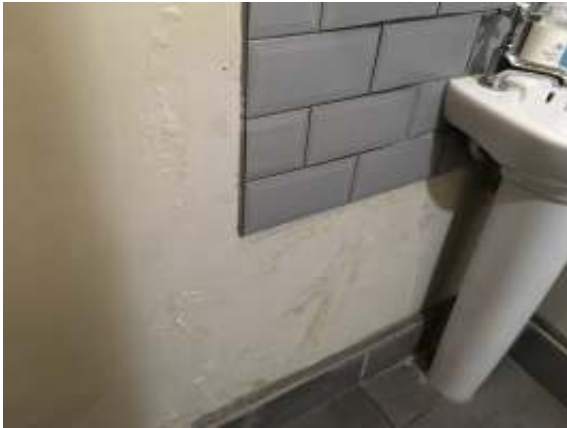
2.7.2	Walls	Mixed timber stud partitions and masonry walls with, plaster finishes, plasterboard lining, ceramic tiles, wood panelling and paint decoration.	Satisfactory Condition - area of damp ingress adjacent to sink.

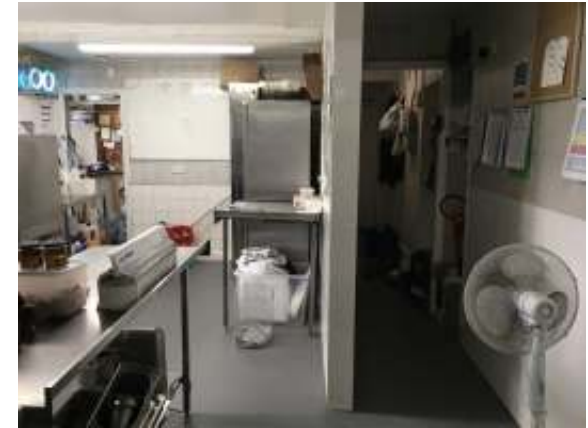
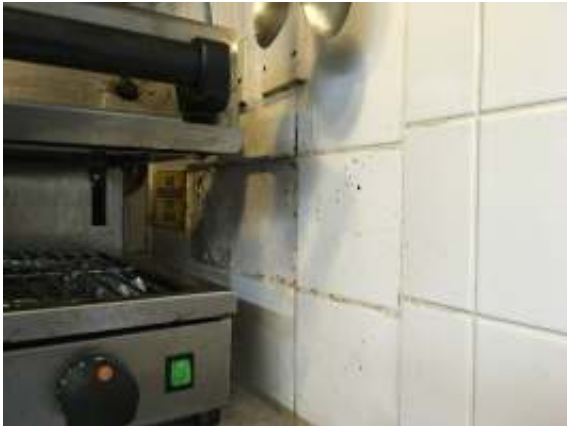
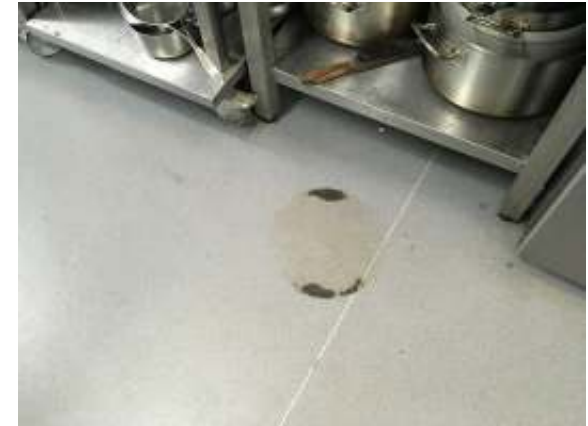
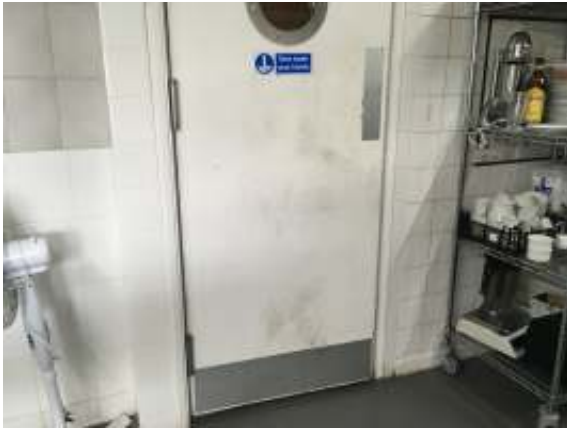
2.8	Commercial Kitchen GF		Photographs [39-44]					
2.8.1	Ceilings	Plasterboard ceiling with painted decoration.	Satisfactory Condition					
2.8.2	Walls	Mixed timber stud partitions and masonry walls with, plaster finishes, plastic and metal cladding and ceramic tiling.	Satisfactory Condition - some tiles cracked/crazed and grout stained. Minor damp ingress to corridor.

2.8.3	Floors	Solid concrete floor with vinyl floor covering.	Good Condition - burn damage.

2.8.4	Joinery	Single glazed timber framed windows, timber fire rated and non fire rated doors, architraves with painted decoration.	Satisfactory Condition - some soiling to doors.

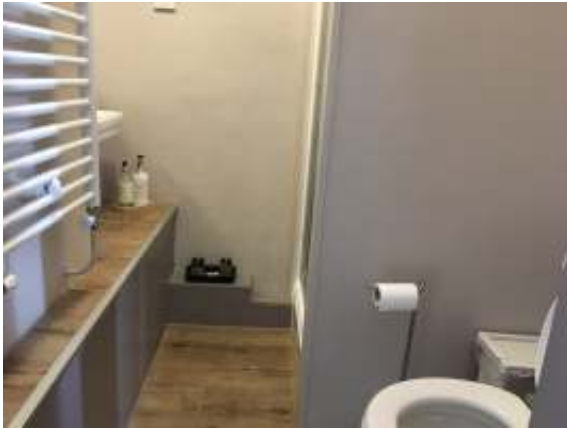
2.12	Room 1 Ensuite		Photographs [50-51]					
2.12.1	Ceilings	Lath and plaster ceiling with painted decoration.	Poor Condition - deterioration to finishes.

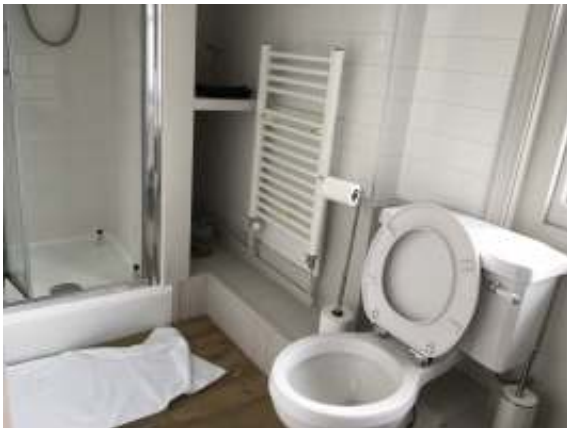
2.14	Room 2 Ensuite		Photographs [53-54]					
2.14.1	Ceilings	Lath and plaster ceiling with painted decoration.	Satisfactory Condition - some damage to finishes.

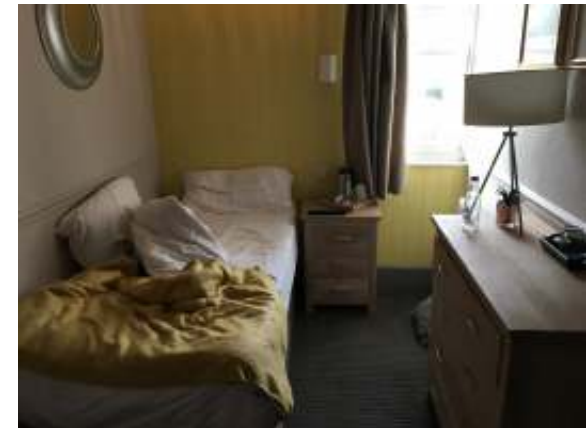
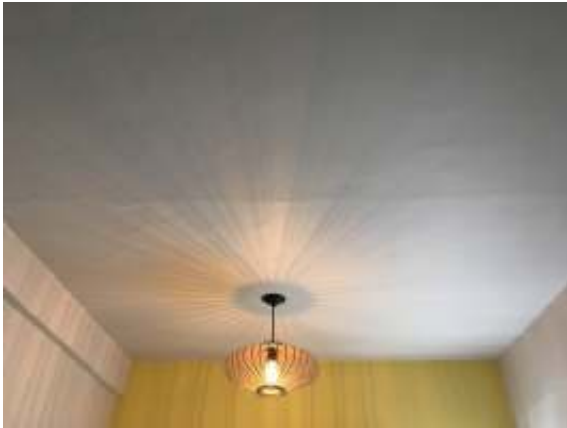
2.15	Room 3		Photographs [55-56]					
2.15.1	Ceilings	Lath and plaster ceiling with painted decoration.	Good Condition - some undulation.					
2.15.2	Walls	Mixed timber stud partitions and masonry walls with, plaster finishes, fibreboard, timber panelling, paper and paint decoration.	Good Condition

2.15.3	Floors	Suspended timber floor with carpet floor covering.	Good Condition - some noise and movement to floorboards on impact at entrance door.
