Schedule of Condition

Fox
29 High Street
Steventon
OX13 6RZ

28th November 2019

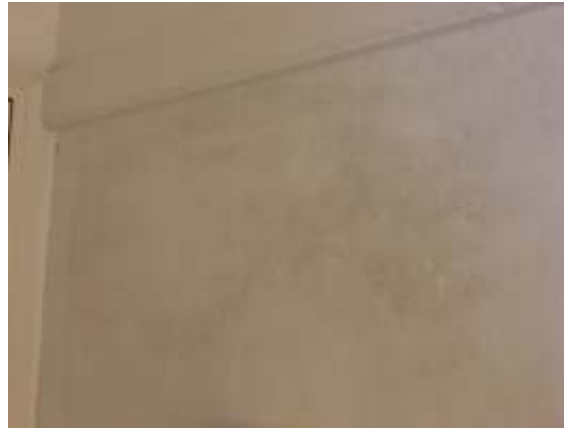
Photo 81

2.28	Private Landing & Cupboards		Photographs [78-84]					
2.28.1	Ceilings	Lath and plaster ceiling with lining paper and painted decoration.	Satisfactory Condition - some deterioration within tank cupboard.

2.28.2	Walls	Mixed timber stud partitions and masonry walls with, plaster finishes, wood panelling and paint decoration.	Satisfactory Condition - incomplete decoration.

2.28.3	Floors	Suspended timber floor with carpet and vinyl floor covering.	Satisfactory Condition - soiling.					
2.28.4	Joinery	Double glazed plastic framed window, timber fire rated and non fire rated doors, skirting boards, architraves, dado rail and with painted decoration.	Satisfactory Condition - lock missing to entrance door. Damage to door frame.
