# Schedule of Condition

Property Address:	Jolly Potters, 296 Hartshill Road, Stoke-On-Trent, Staffordshire, ST4 7NH		
Property Reference Number:	2302826101		
Document Reference:	MMP/caw	Rev.	
Survey Date:	13 <sup>th</sup> April 2022

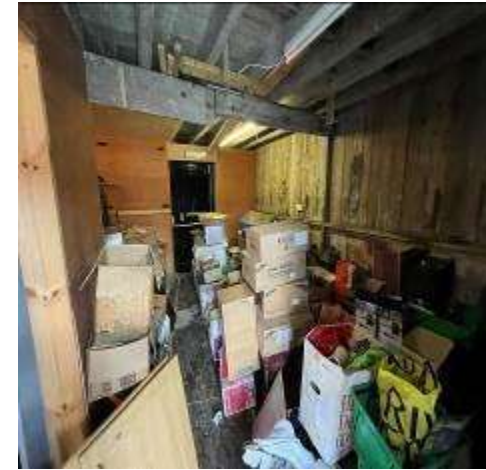
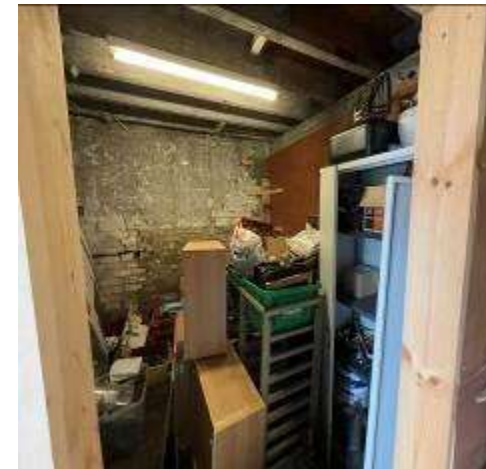
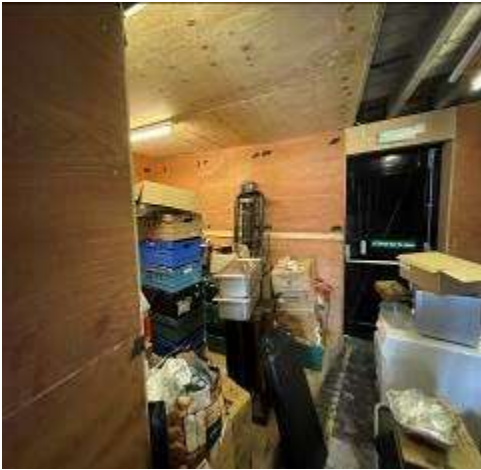
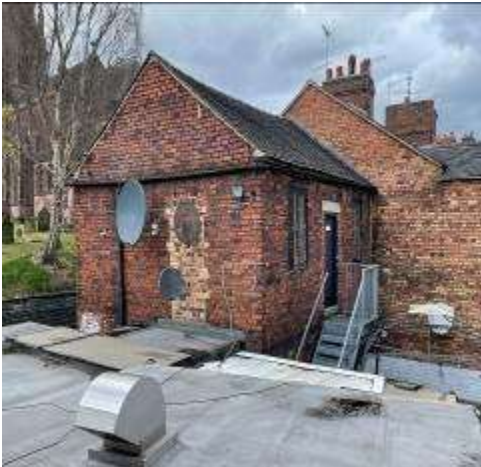
5.3	<b>Detached outbuilding</b>		<b>Photos 95-97 / 118</b>			
5.3.1	General	Attached to neighbouring premises. Of traditional construction with brick facing elevations set beneath pitched roof overlaid in red tiles incorporating cast iron rainwater goods and timber framed doors and windows.	1-2 Deterioration to rainwater goods requiring overhaul. Main pitched roof will require ongoing repairs. External decorations weathered. Pointing weathered and incomplete.
